Fort Monroe Historic Viewsheds

Megan Weaver Tooker, Adam Smith, Chris Cochran, and
Chelsea Pogorelac

Final report

Prepared for DPW-Environmental Branch
Fort Monroe
318 Cornog Lane, Bldg 28
Fort Monroe, VA 23651

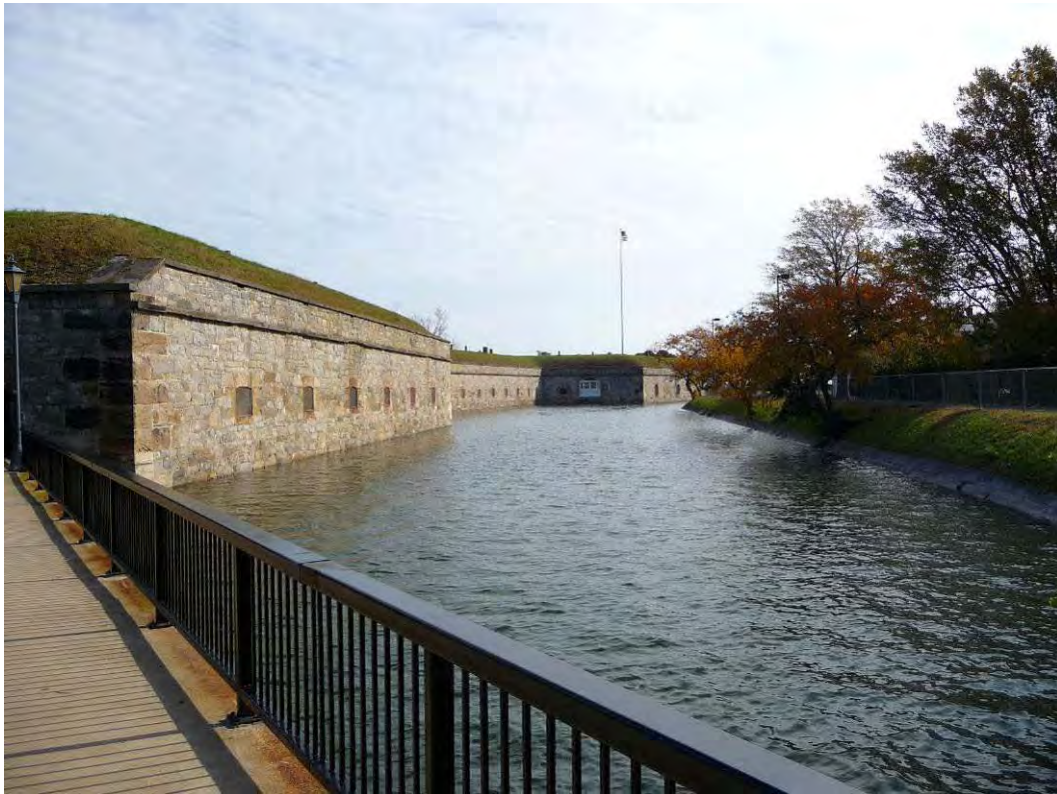
Figure 111. Looking from the postern gate, 2009.

This view of the postern gate, fort, moat, and flagstaff retains its historic integrity.

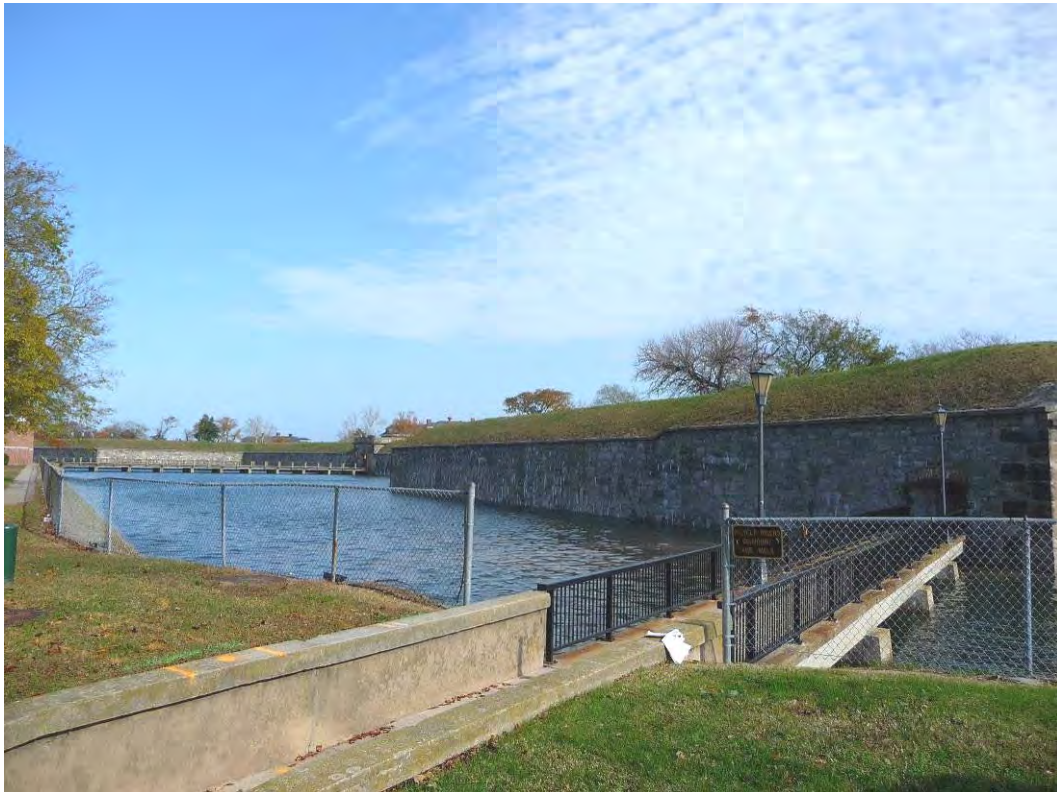
Figure 113. Looking at the postern gate, 2009.

The postern gate and view to main gate remains the same with the exception of the missing tower.

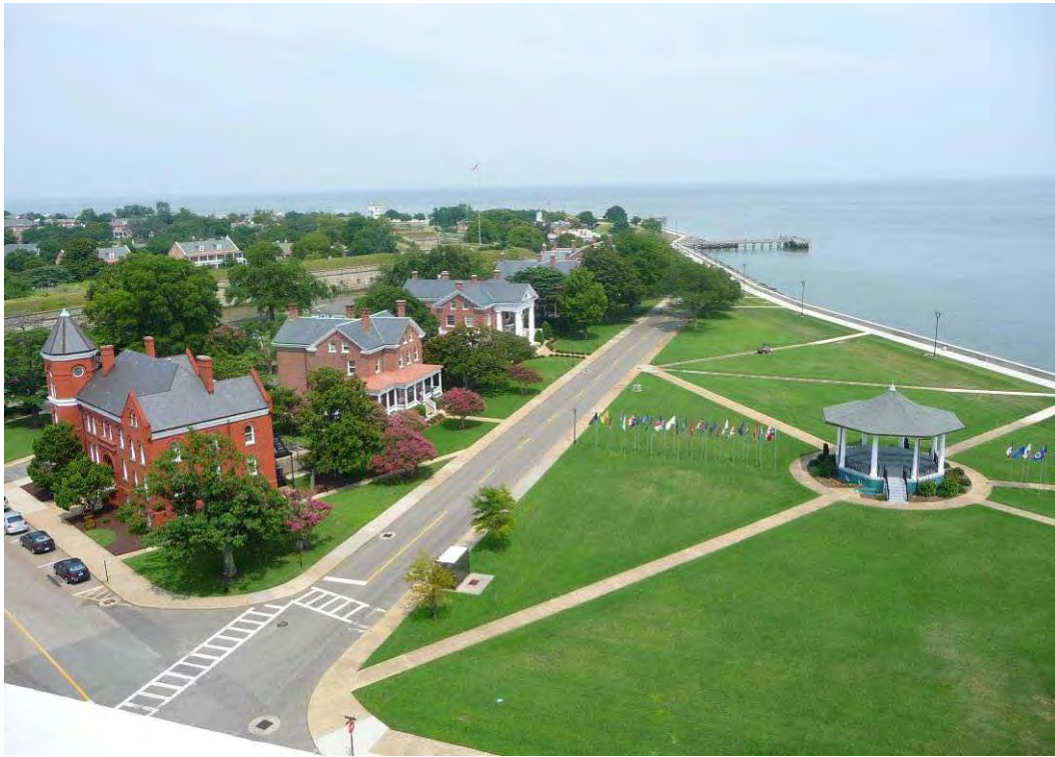
Figure 122. Fort Monroe Waterfront, 2009.

Today this view from the top of the Hotel Chamberlin remains almost unchanged.

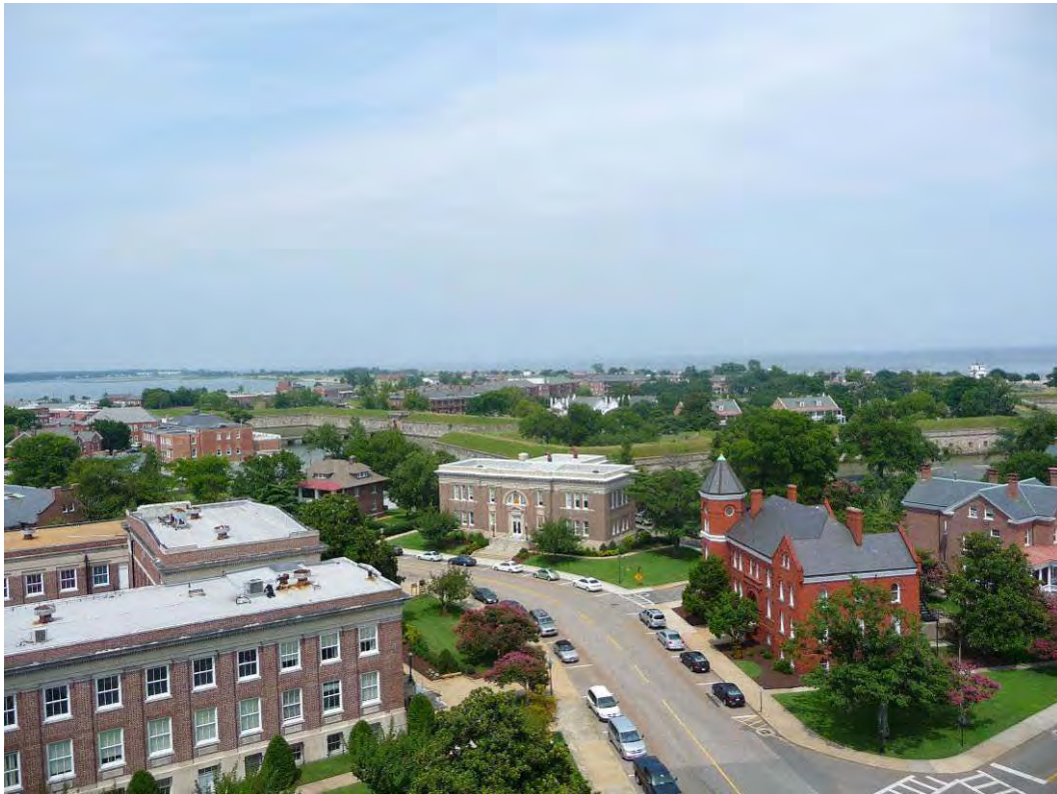
Figure 125. Looking up Ingalls Road from the Hotel Chamberlin, 2009.

The Coast Artillery School buildings still dominate this view, although the moat, fort and buildings inside the fort are still visible.

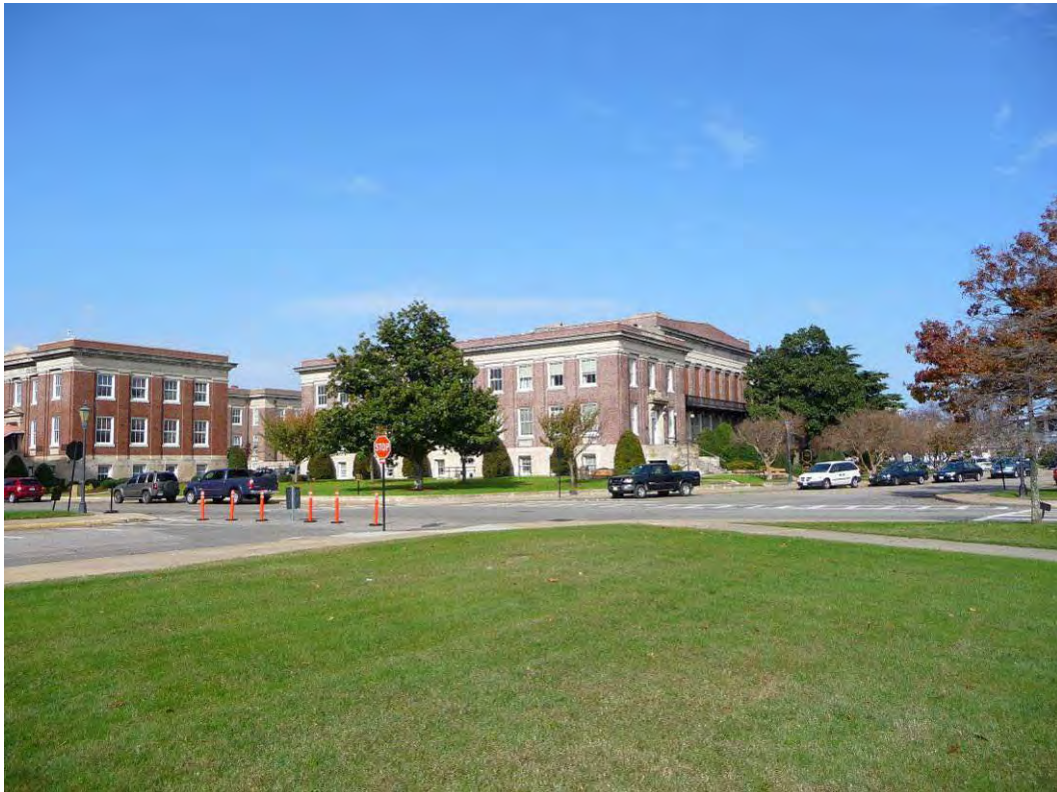
Figure 129. Former Coast Artillery School buildings, 2009.

The view to the former Coast Artillery School buildings from Continental Park is still dominated by the impressive architecture of these buildings.

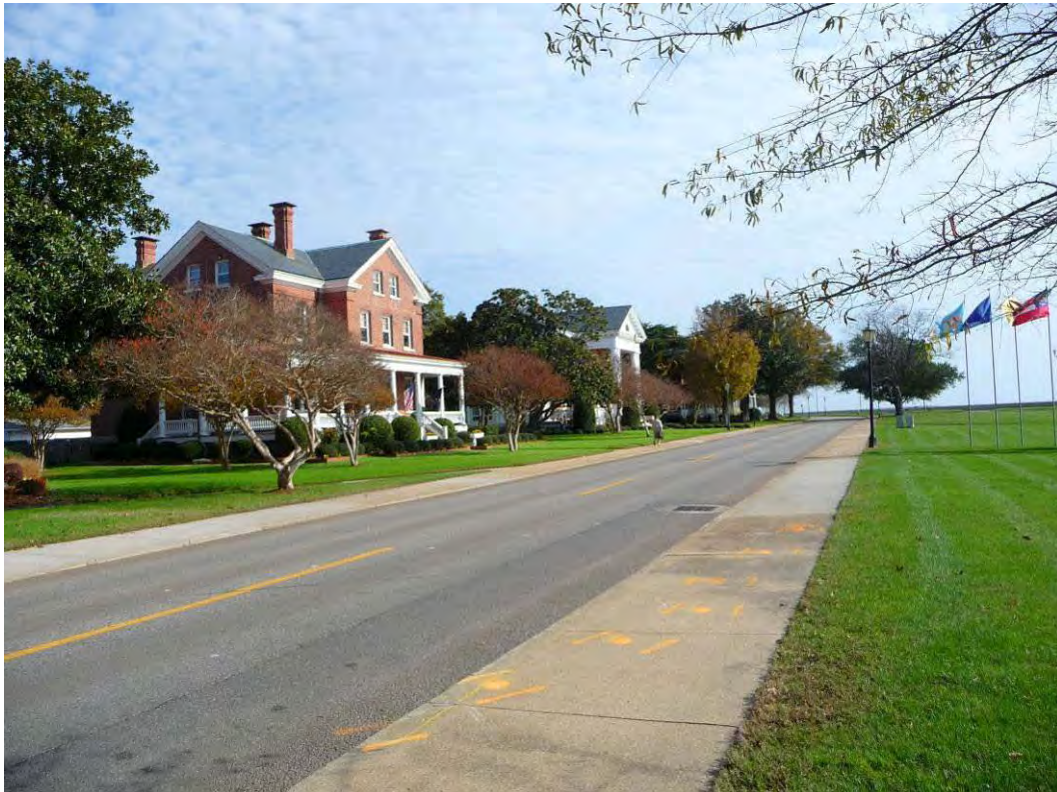
Figure 132. Officers' Row on Fenwick Road, 2009.

This view of officers' quarters along Fenwick retains its integrity today.

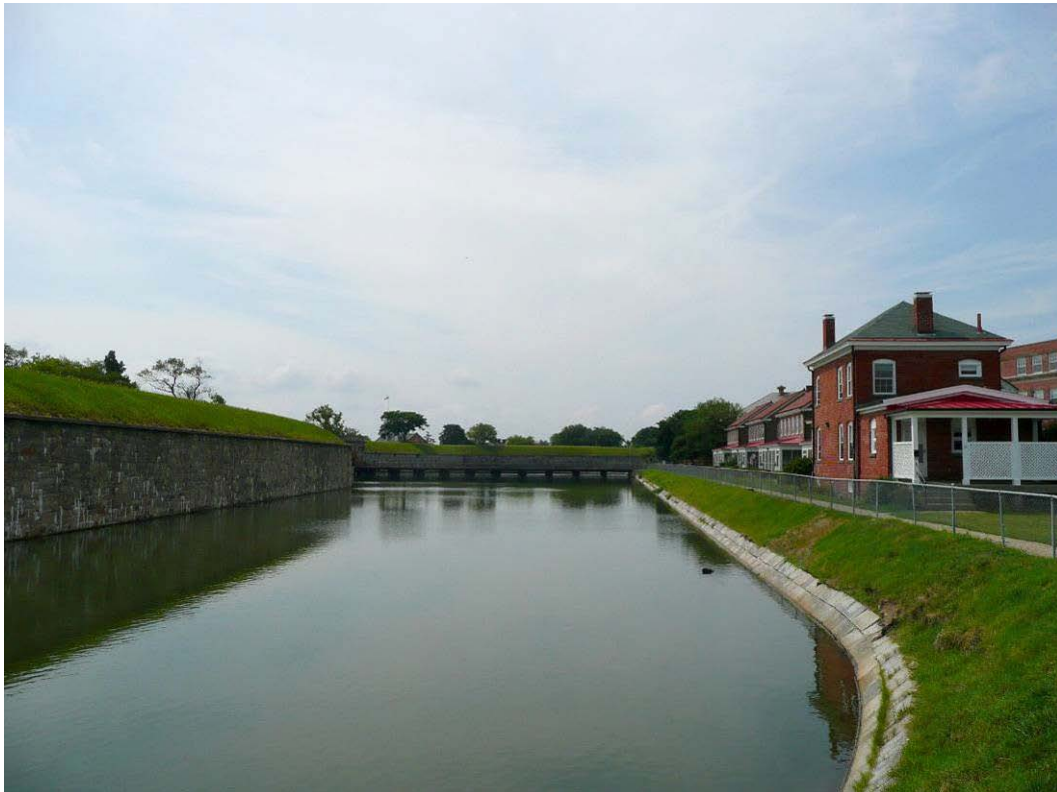
Figure 134. The moat and main entrance, 2009.

The moat and fort remain unchanged as do the quarters and buildings to the west of the moat. Water tower is no longer extant.

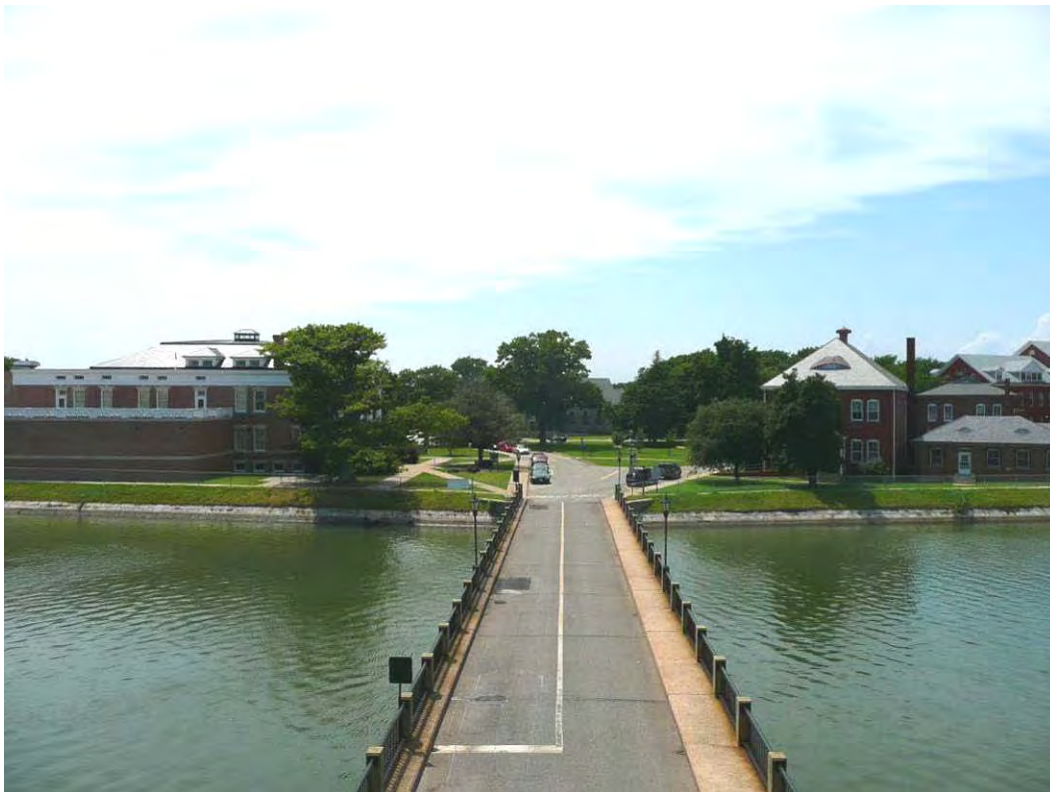
Figure 139. Looking west from atop Main Gate, 2009.

The current view from the Main Gate of the fort toward the Headquarters, YMCA, Catholic Chapel and Cannon Park retains most of its integrity.

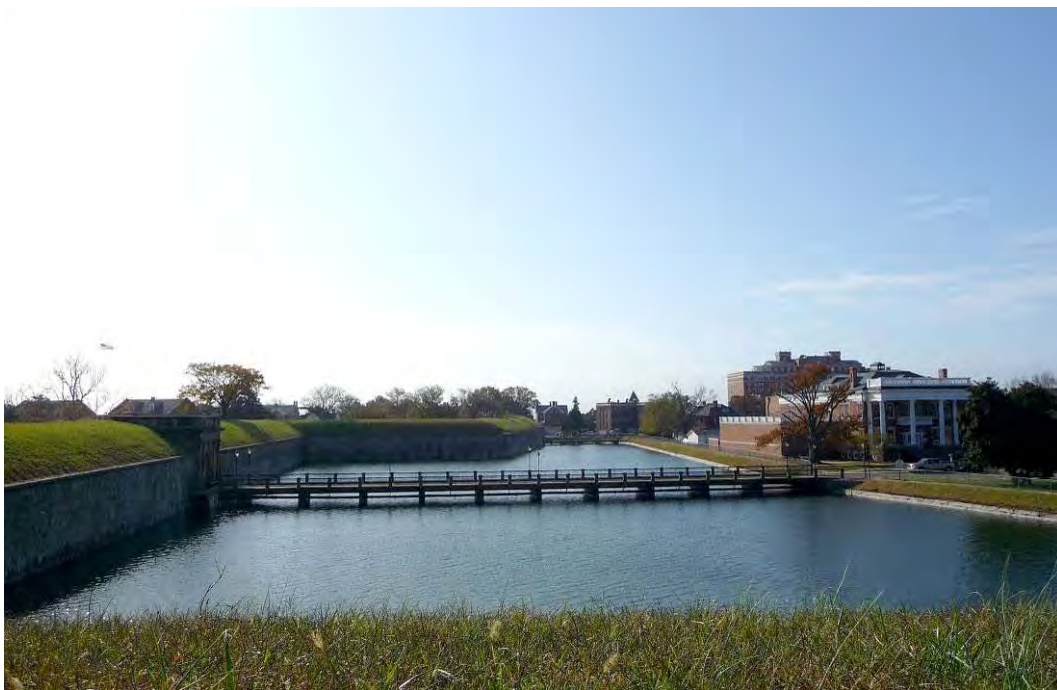
Figure 141. View south towards Main Gate, 2009.

This view of the fort, moat and main gate remains unchanged today.

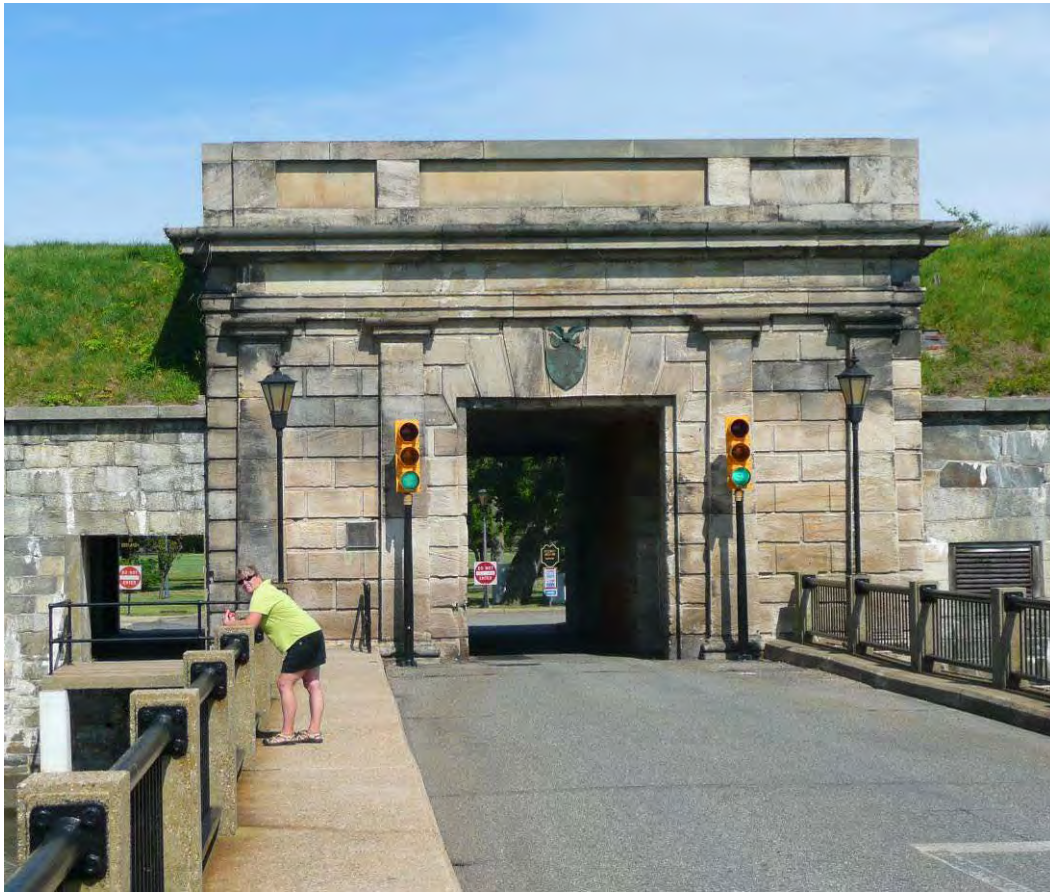
Figure 146. View of Main gate, 2009.

A passageway for walkers has been added on the left as well stop lights and signage. Bridge material has been changed over the years to accommodate vehicle traffic.

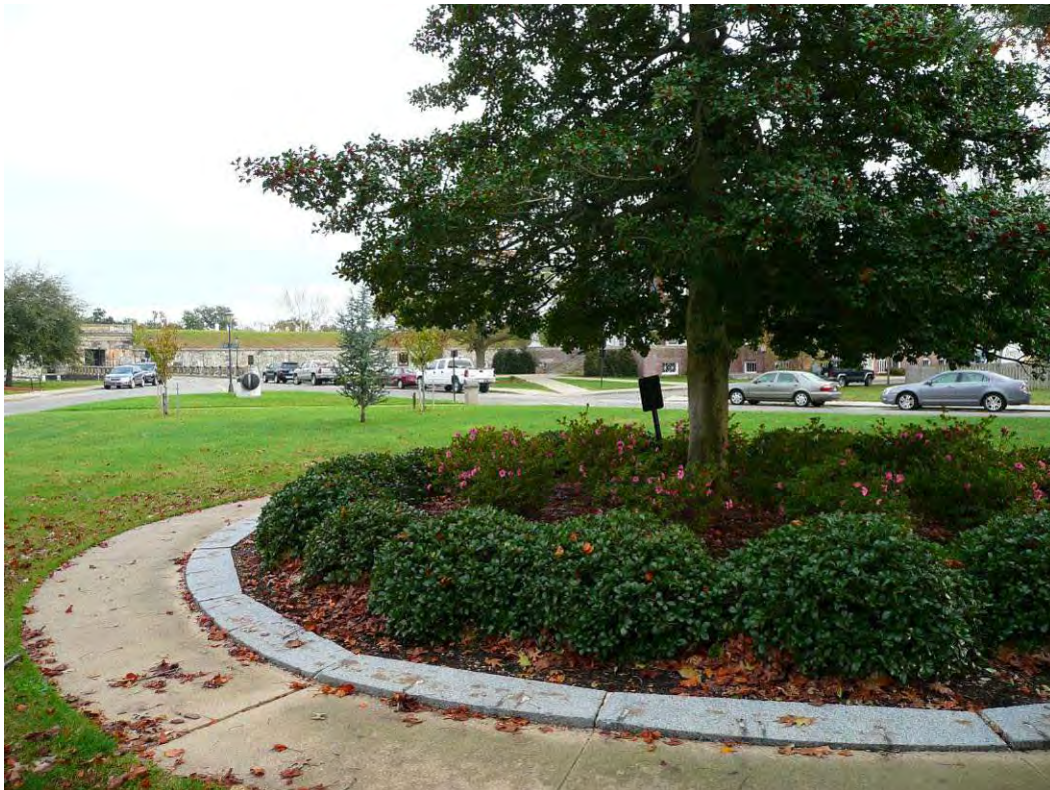
Figure 151. YMCA and Main Gate from Cannon Park, 2009.

Vegetation in the park and parking along the road has obscured the main gate partially over the years.

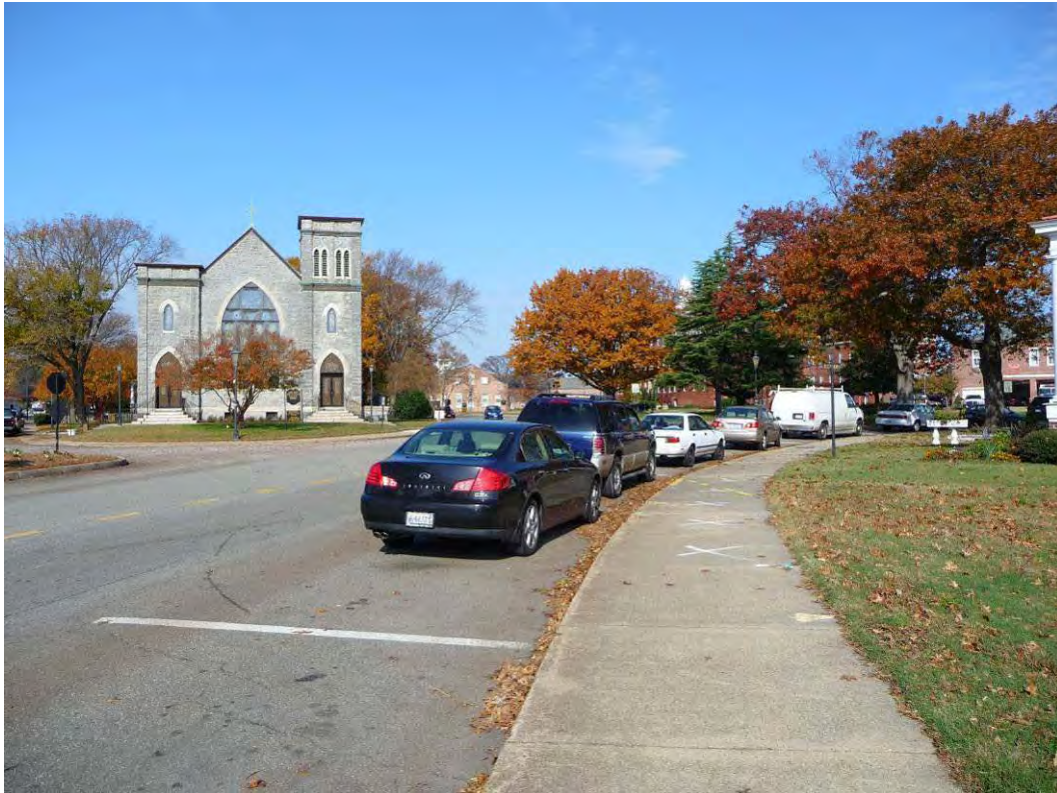
Figure 154. St. Mary Star of the Sea, 2009.

The current view of the Catholic Chapel retains its integrity.

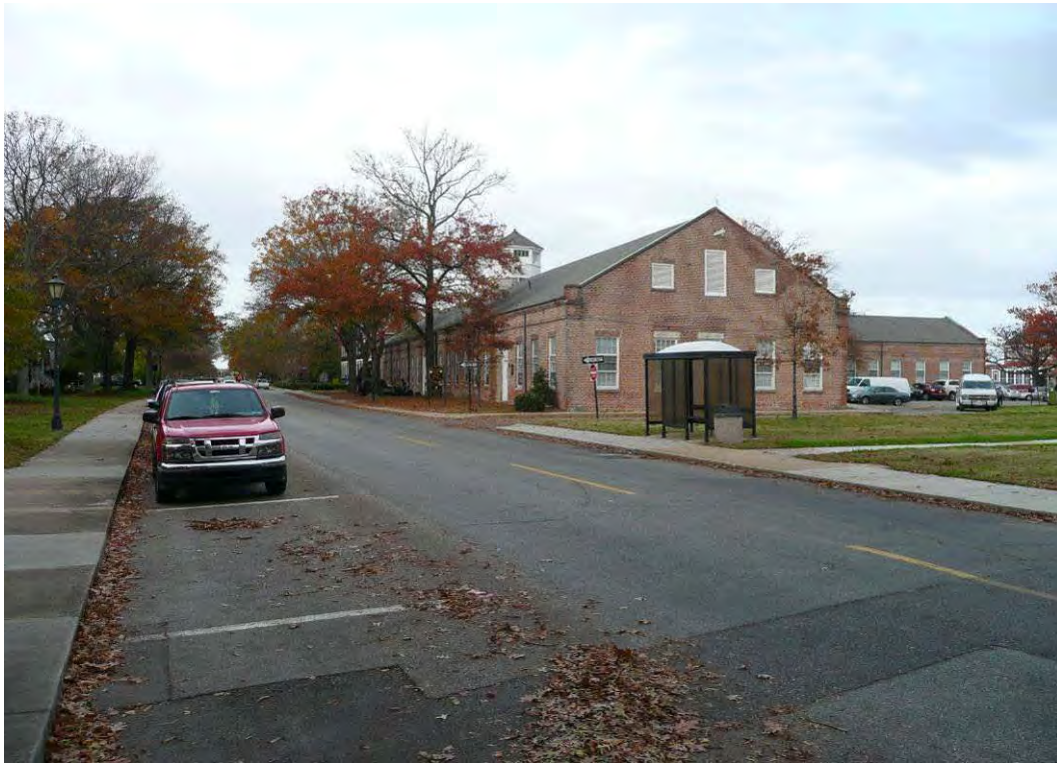
Figure 159. Former arsenal (Building 27) on Ingalls Road, 2009.

Ingalls Road is still a main thoroughfare and retains its integrity.

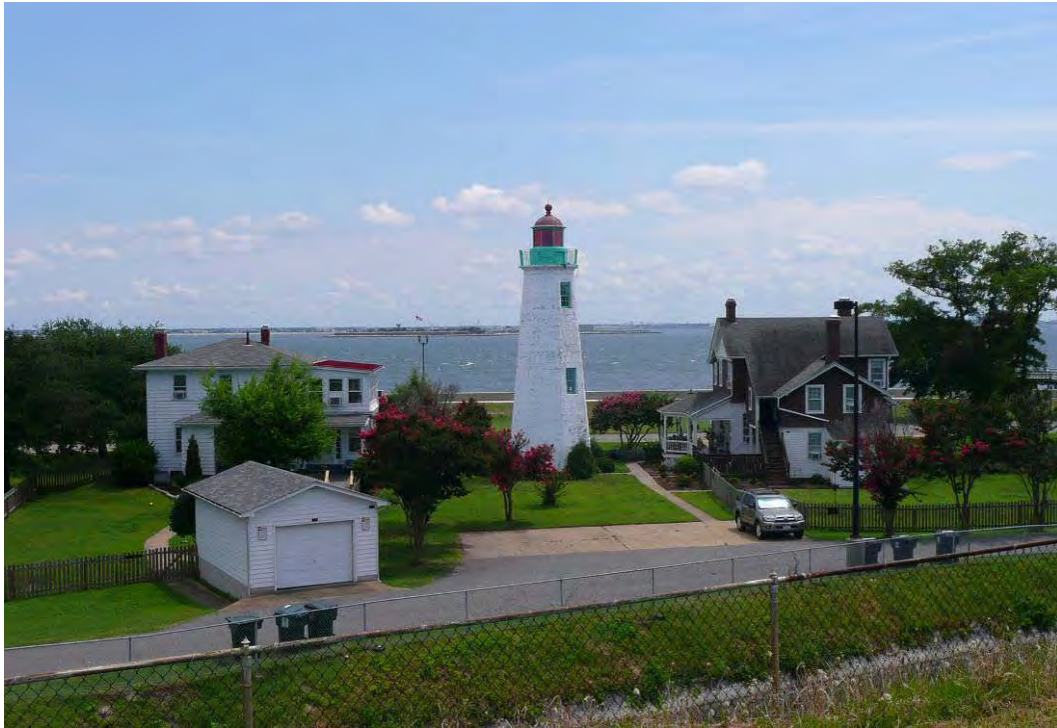
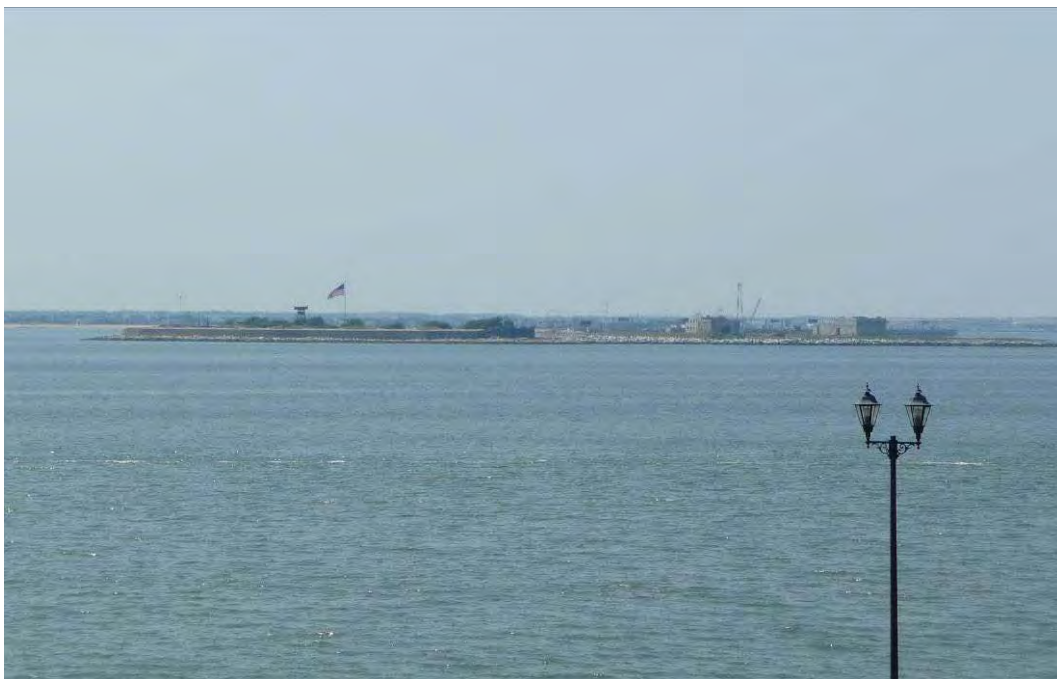
Figure 162. View from Fort Monroe to Fort Wool, 2009.

The view of Fort Wool now contains the Hampton Roads Bridge-Tunnel.

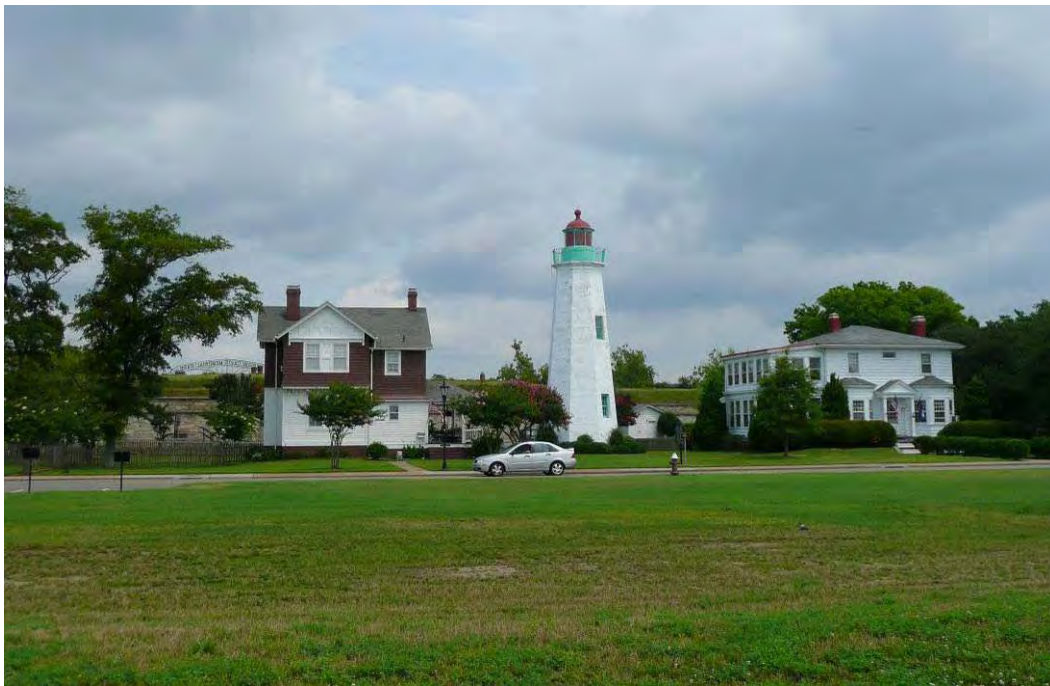
Figure 167. View of lighthouse and keeper's house, 2009.

The lighthouse and keepers quarters are still visible from the water.

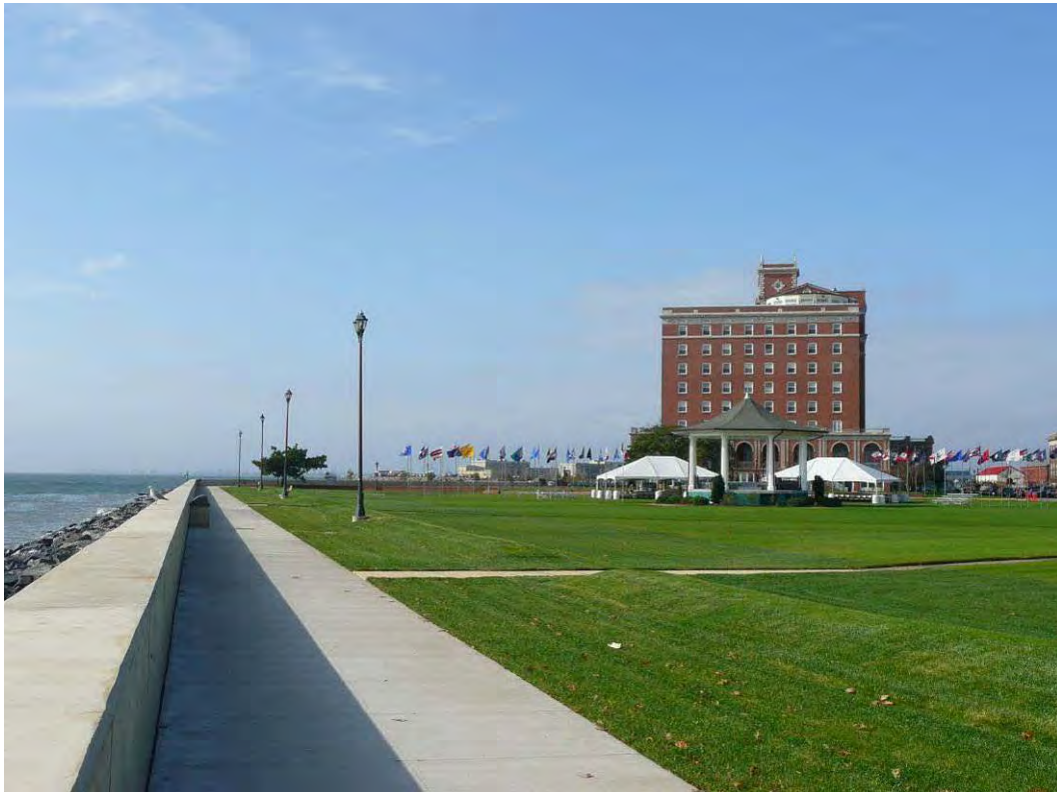
Figure 171. View west toward Continental Park and Hotel Chamberlin, 2009.

While the view across the open space of the park toward the Hotel Chamberlin remains unchanged today, the bandstand and Baltimore Wharf are missing along the waterfront and a new larger seawall has been added.

- Missing Baltimore Wharf
- Flags and lighting

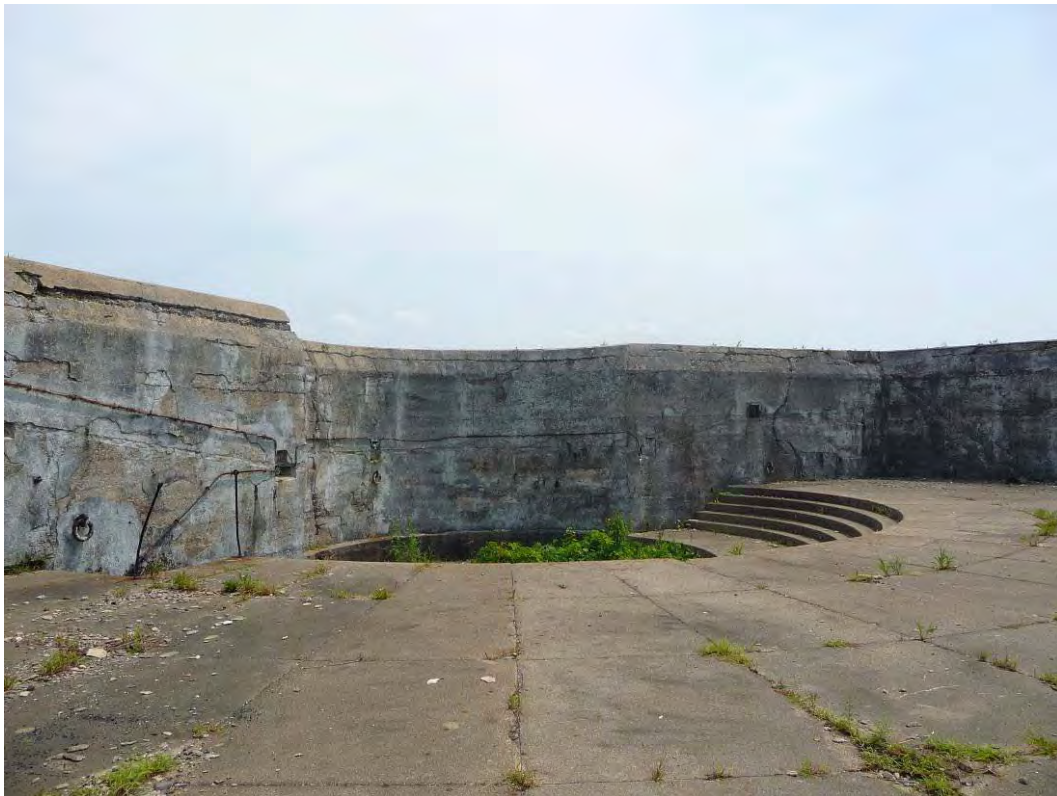
Figure 175. View of Battery DeRussy, 2009.

Almost all of the batteries still have clear views to the water. However, the view from Battery DeRussy is partially obscured by housing built between the battery and water. In addition, several batteries are missing their earthen embankments and all but two are closed.

- Missing guns
- Wherry housing built between battery and water
- Overgrown vegetation
- Condition (closed to visitors)

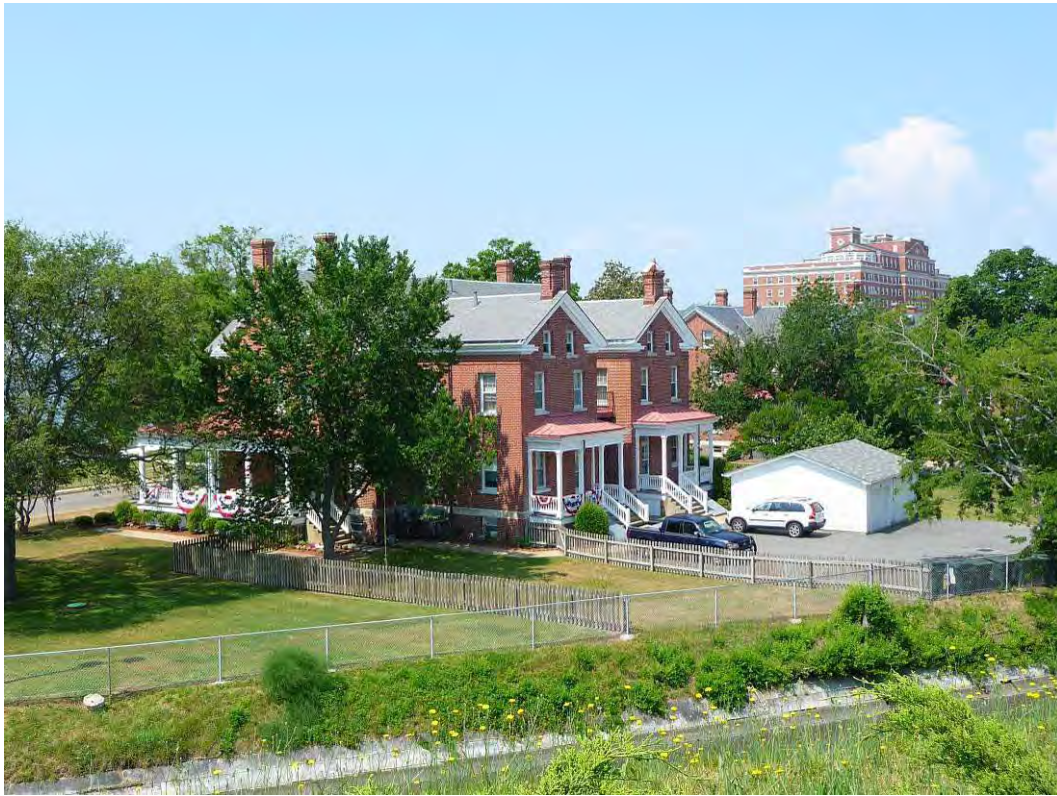
Figure 178. View from first front, 2009.

The views from the first front of the fortification have always been partially obstructed by buildings. While the fort was being built, engineering buildings and yards occupied the land outside the fort at this front. Later this area contained quarters and administration buildings. In the late 1800's, the Hygeia and Hotel Chamberlin were built and obscured firing lines and views from this front. No historic photograph was found of this view.

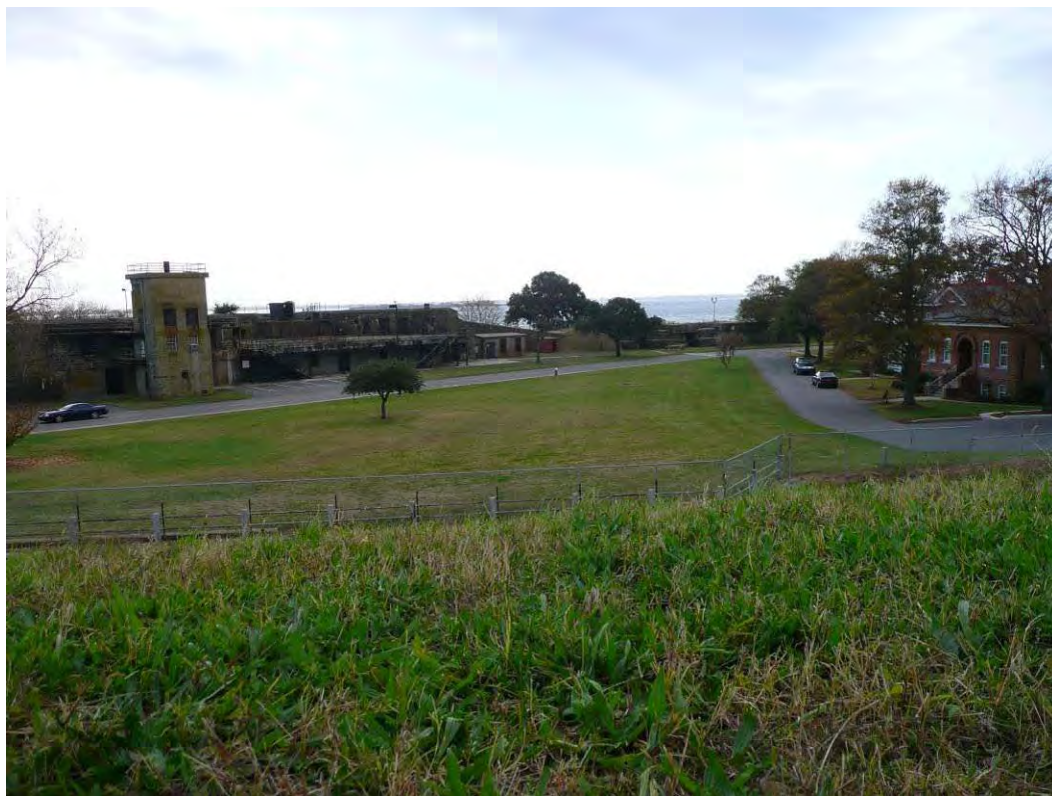
Figure 183. View from third front, 2009.

- Missing water battery
- Overgrown vegetation
- Condition of Batteries
- Chain-link fencing

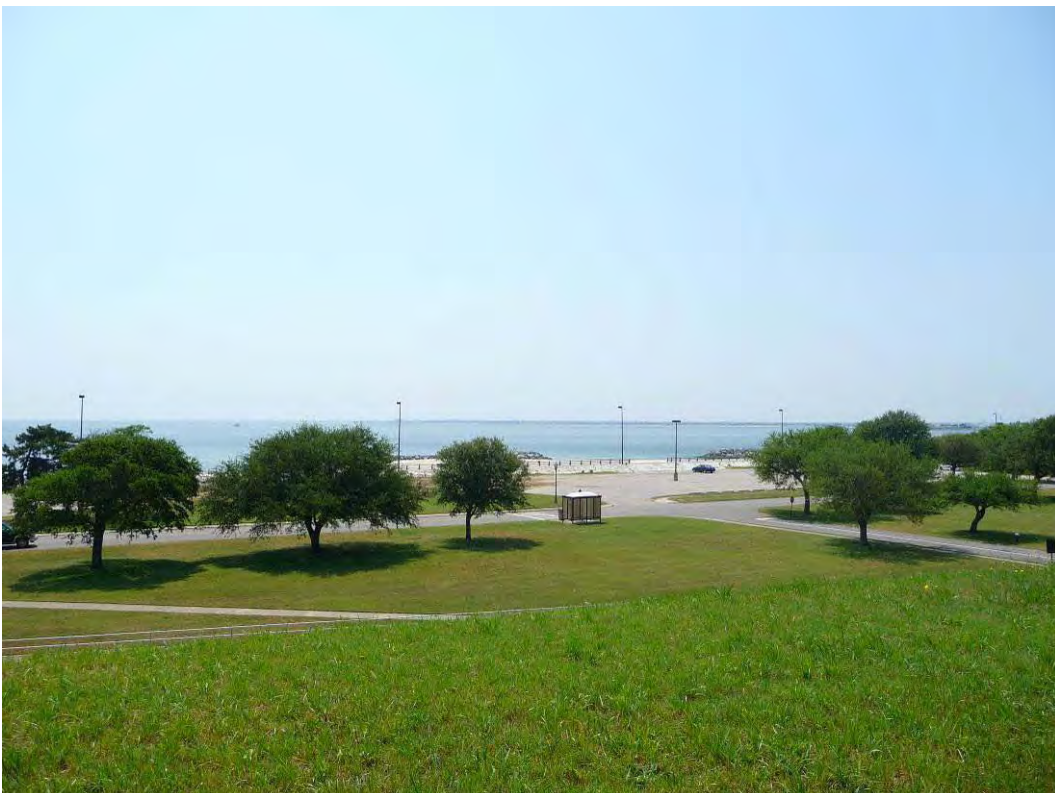
Figure 185. View from fourth front, 2009.

While in the past temporary buildings have occupied the strip of land across from the east gate, it is currently open and used as a parking lot.

- **Missing water battery**
- **Lighting, bus stop, parking lot**

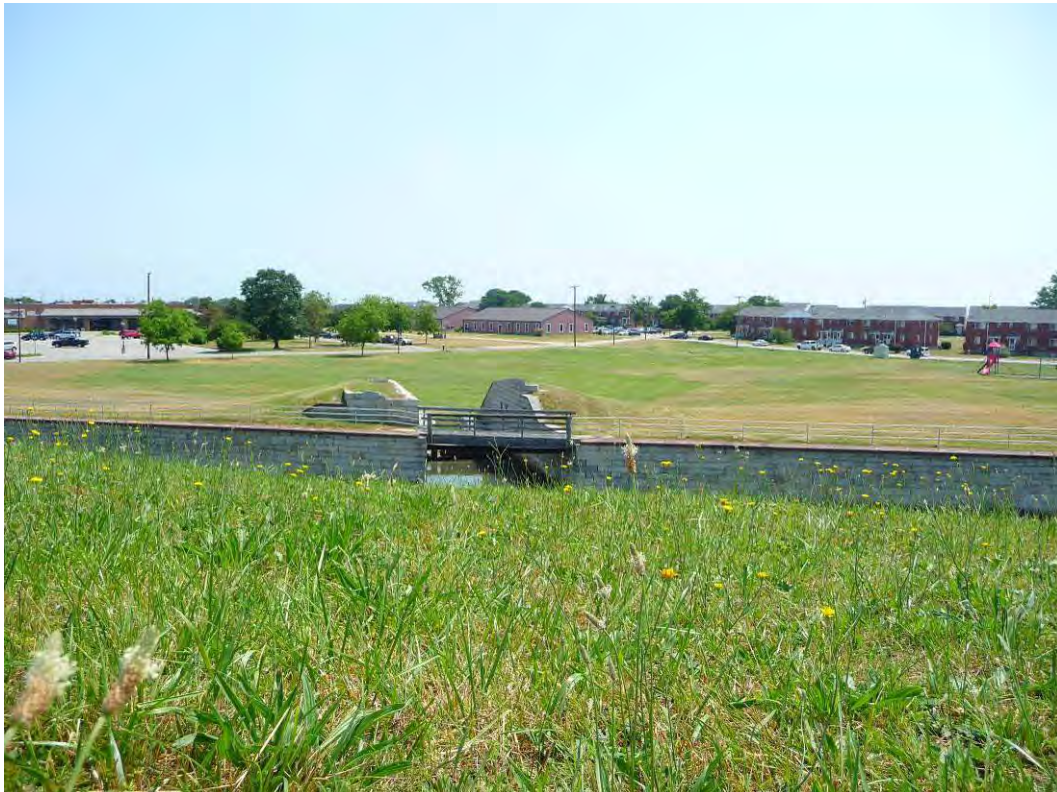
Figure 187. View from fifth front, 2009.

- Parking lots
- Lighting
- Missing redoubt, moat and other features

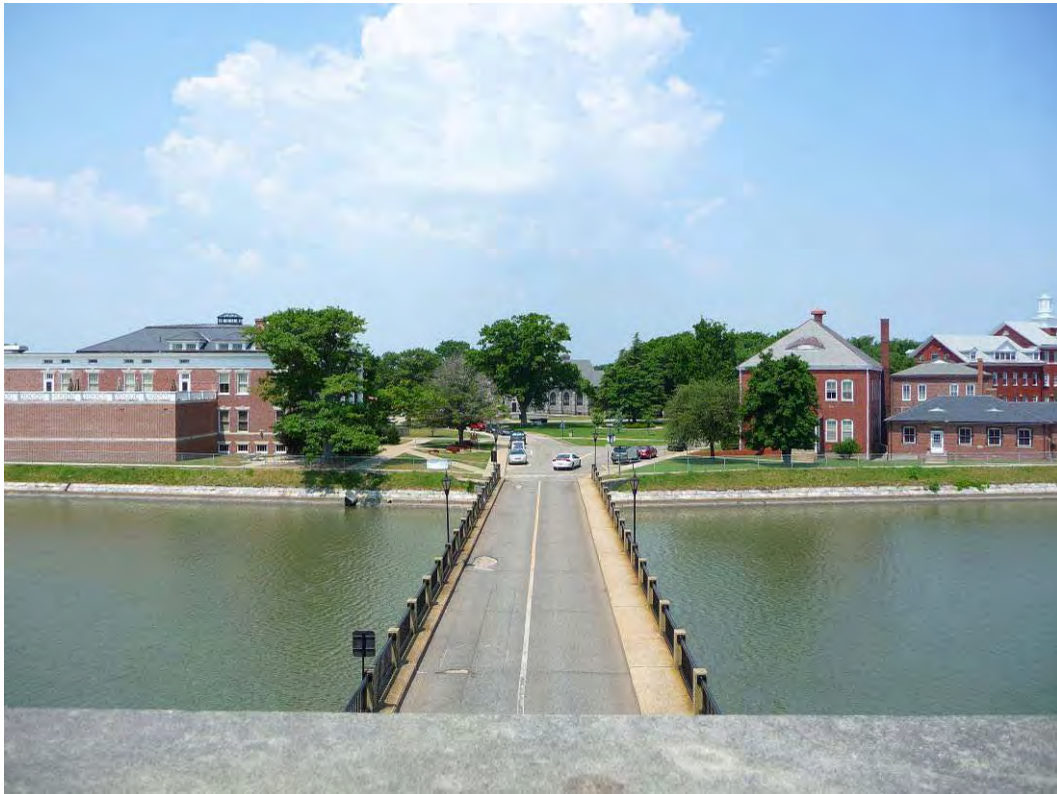
Figure 192. View from seventh front, 2009.

The current view from the seventh front is quite similar to the historic post card shot from the early 20th century.

- Missing view to water/Hampton Roads
- Vehicles and parking

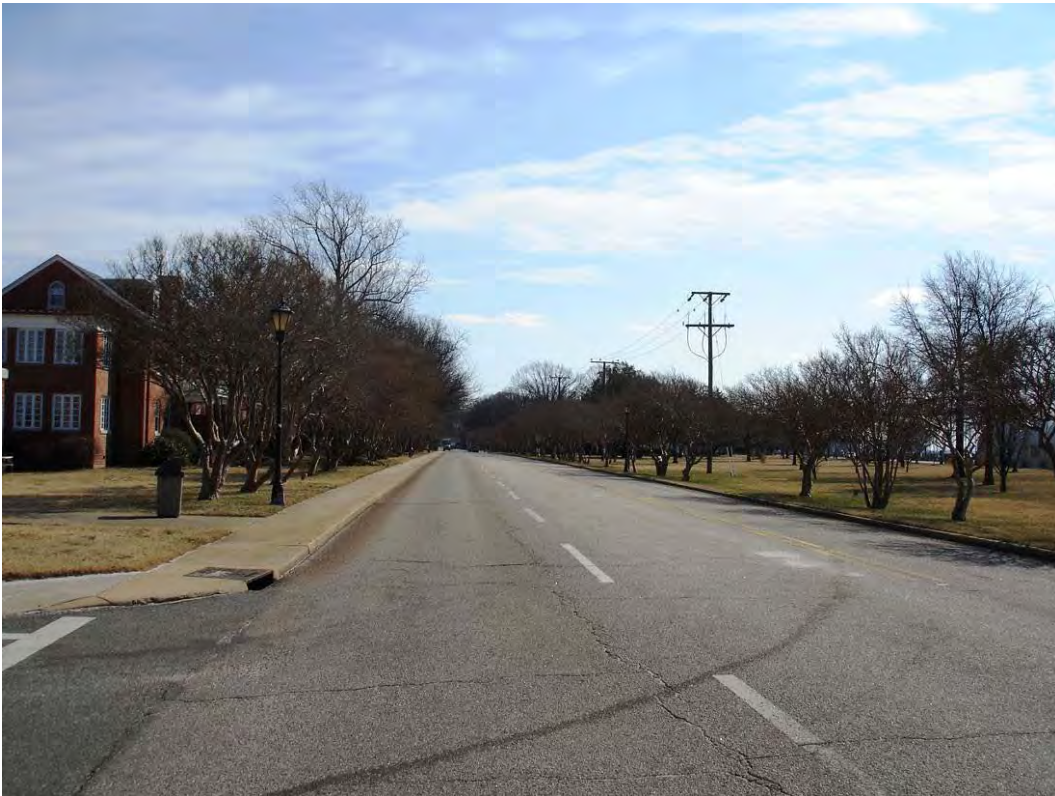
Figure 194. View down Ingalls Road from entrance, 2010 (Fort Monroe Cultural Resources).

Today, new security measures associated structures and features have altered the view of the entrance to Fort Monroe.

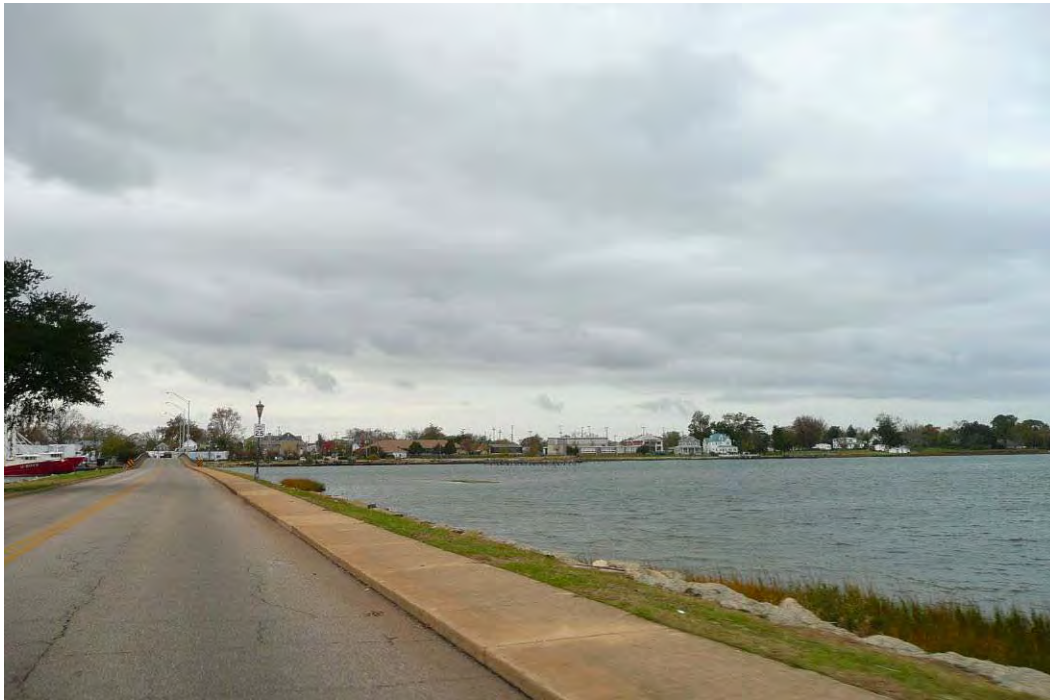
Figure 197. View of Phoebus (Camp Hamilton site) from Fort Monroe, 2009.

Over the years, houses and businesses, docks and boats have been added to this view of Phoebus. Camp Hamilton is no longer present so the integrity is lost.

- Homes replaced Camp Hamilton (hard to visualize)
- Newer homes and businesses along shore
- Docks and boats

- Maintain park and interpretive signage about visual connection between the two sites

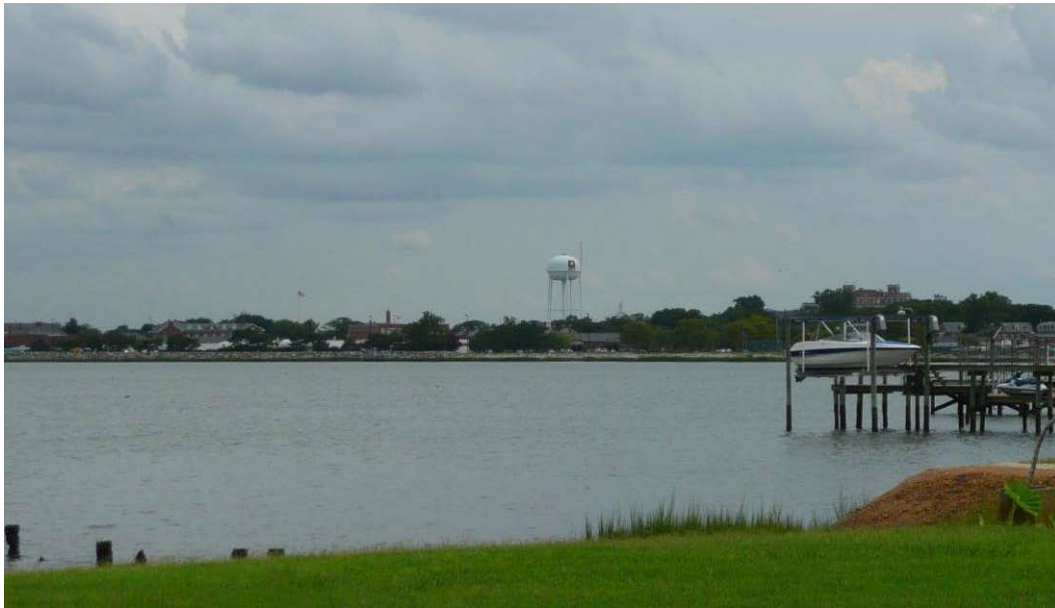
Figure 200. View towards Fort Monroe from Phoebus, 2009.

The current view is dominated by water and the bridge. Due to vegetation, new construction and the addition of docks on the Phoebus side, the historic architecture is less visible today.
